**THE IN-VITRO EFFECT OF PROBING AND SCALING INSTRUMENTATION  
ON IMPLANT RESTORATIVE ABUTMENT SURFACES**

A Thesis  
Submitted to  
Temple University Graduate Board

**Dr. Behnam Fakhravar, D.M.D.**

**May, 2011**

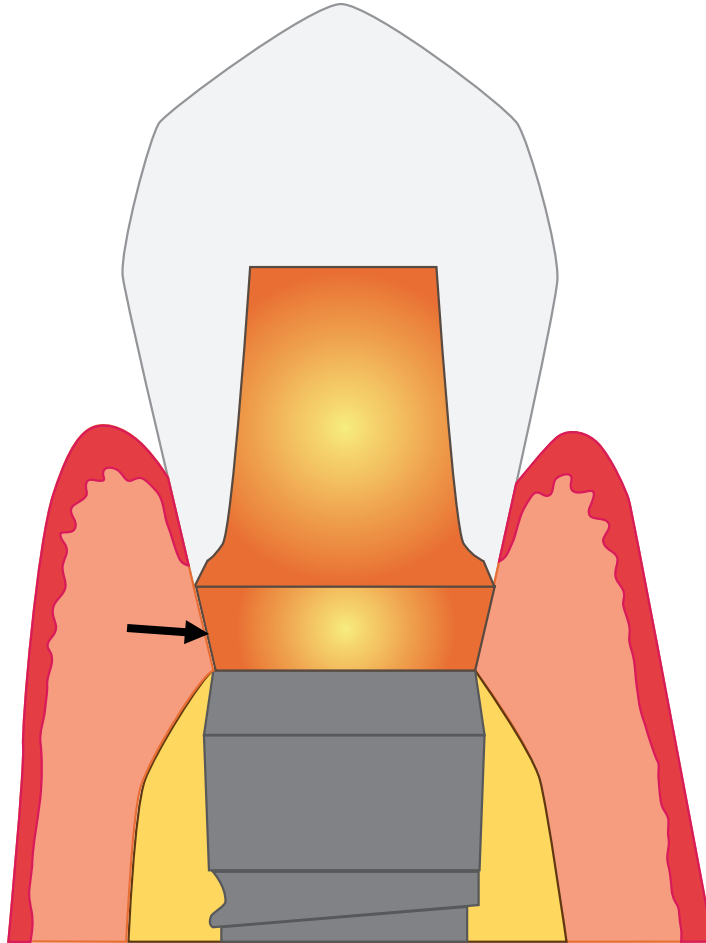
**Fig. 1.** The apical metal collar of the implant abutment. This area (as indicated by the arrow) is vulnerable to surface changes during instrumentation.

Dental implants are usually placed in the jawbones with the implant fixture's coronal surface at the alveolar crest. The implant abutment interfaces with the implant fixture's coronal surface. The apical portion of the implant abutment, an exposed collar of metal, is usually coronal to the alveolar crest. The oral mucosal tissues surround this collar of metal and create a soft tissue seal around the implant-abutment interface. The function of this peri-implant seal is to maintain a barrier to outside contaminants. It does so by shielding the implant-abutment interface and the alveolar bone encompassing the implant.

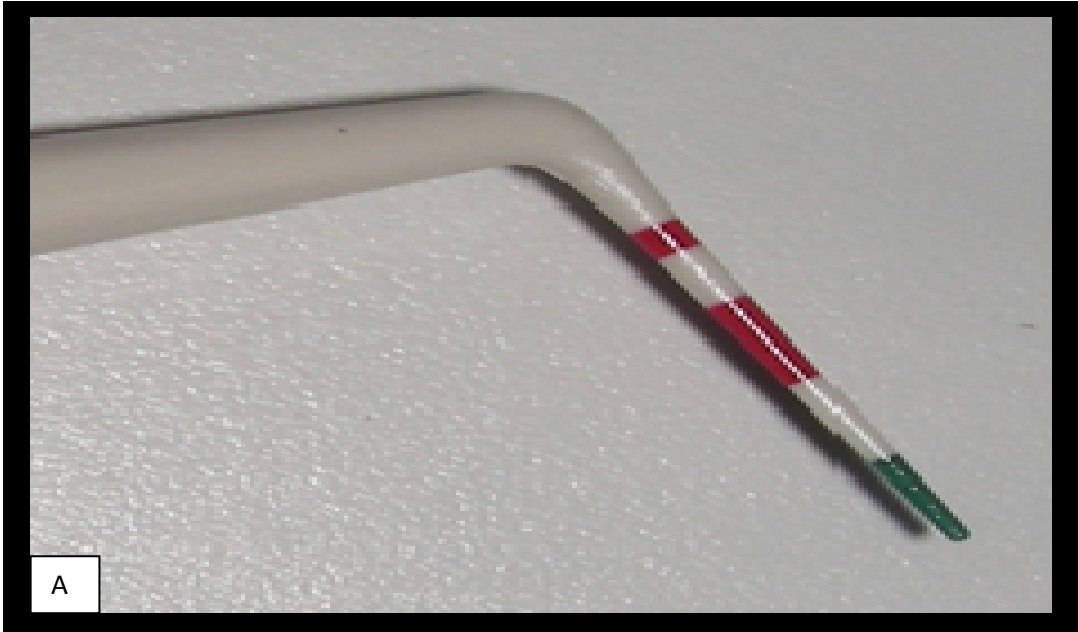
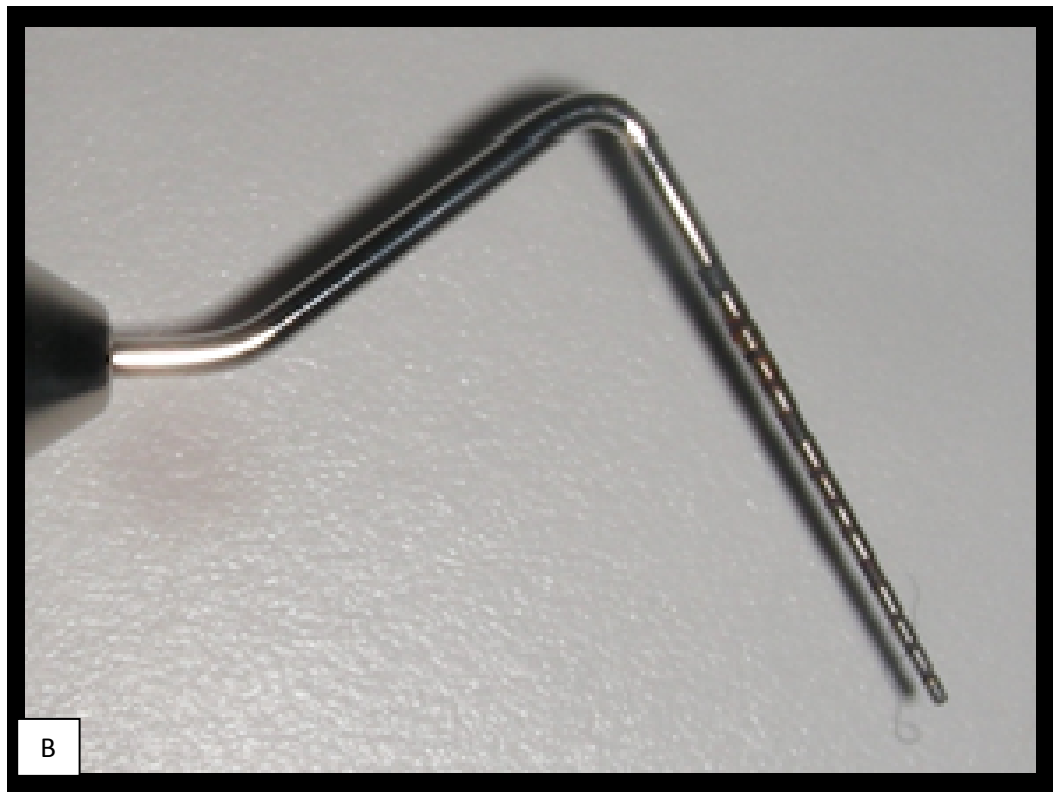
**Fig. 2.** Periowise plastic probe (A), UNC-15 metal probe (B).

Each test abutment was treated in-vitro with 4 different instruments: UNC-15 metal probe (Hu-Friedy, Chicago, IL), Periowise plastic probe (Premier dental, Plymouth Meeting, PA) (Figure 2), metal scaler (McCall SM 17/18, Hu-Friedy, Chicago, IL) and plastic scaler (universal configuration, Hu-Friedy, Chicago, IL) (Figure 3). In preparing the abutments for the study procedures, the abutments were handled by the coronal portion, thus the portion of the titanium surface subjected to test conditions was otherwise untouched.

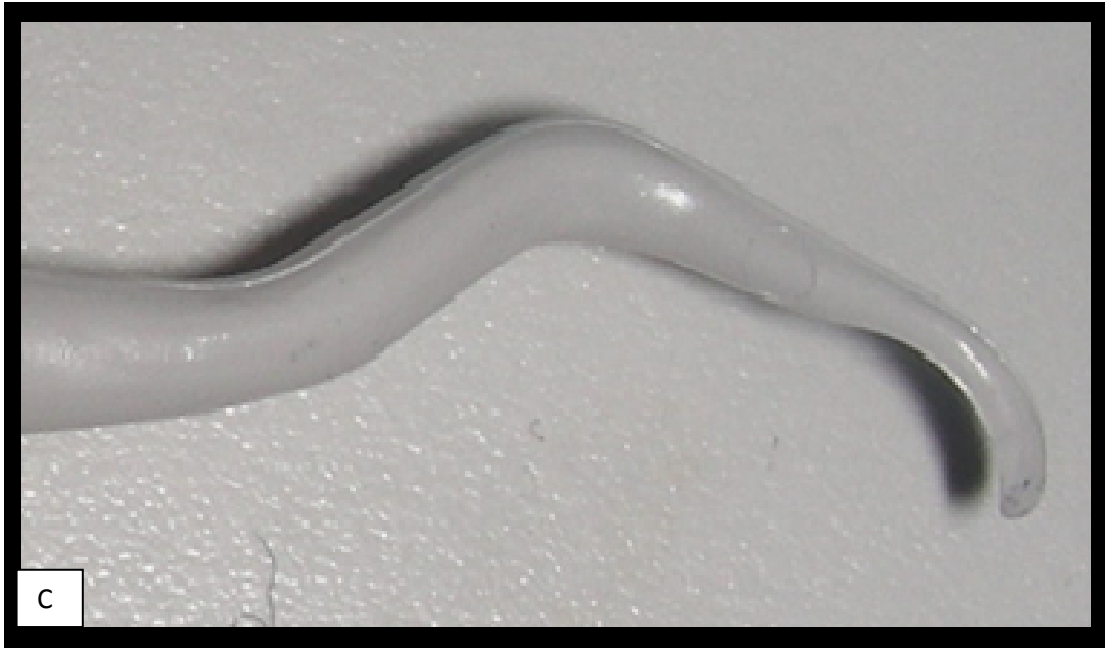
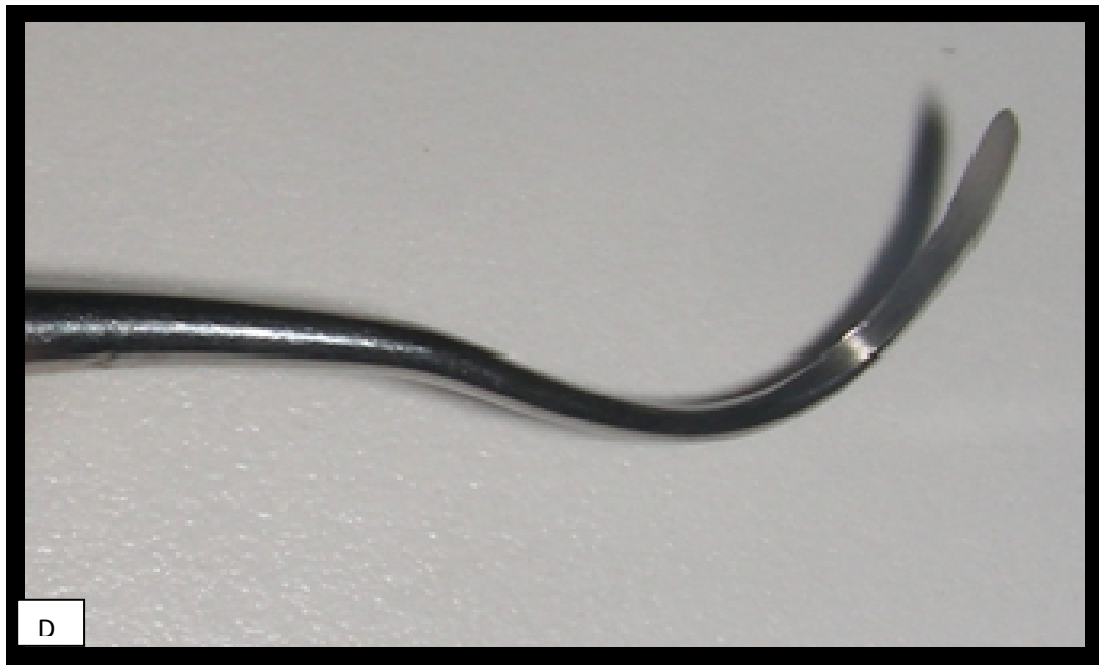
**Fig. 3.** Universal plastic scaler (C), McCall SM 17/18 metal scaler (D).

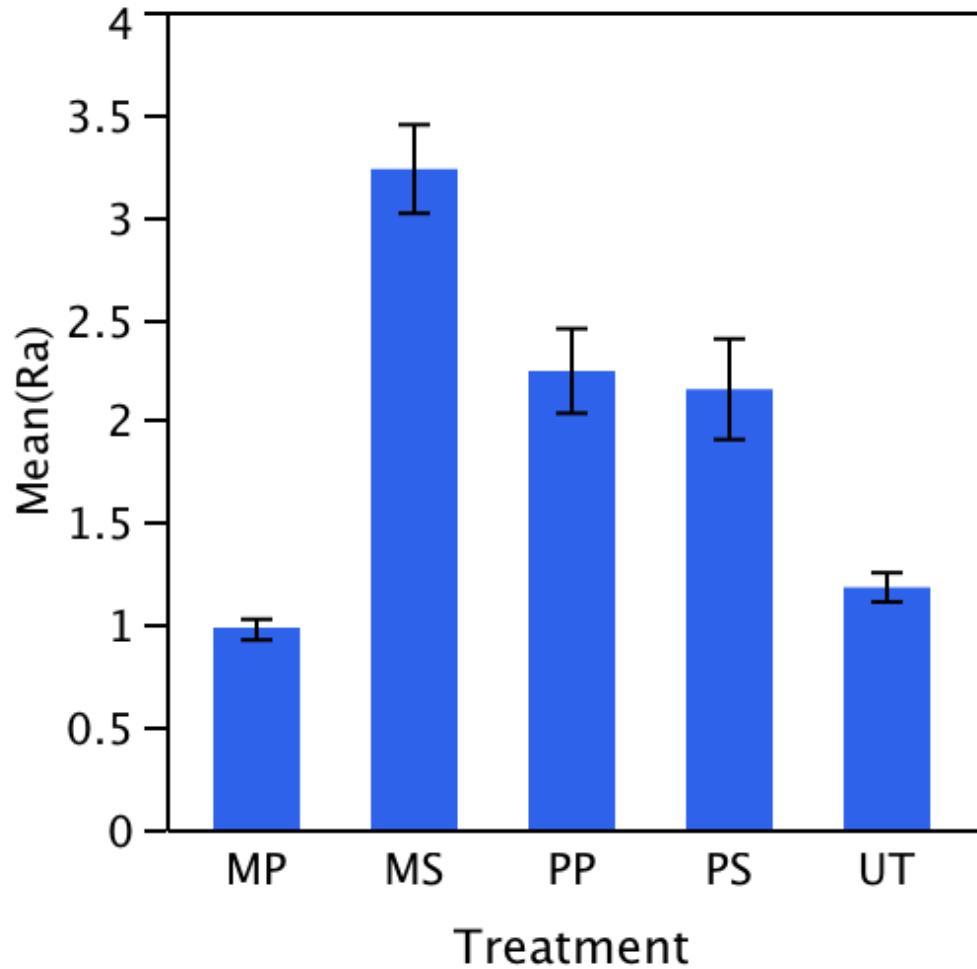
**Fig. 6.** A chart showing average surface roughness (Ra) by treatment; metal probe (MP), metal scaler (MS), plastic probe (PP), plastic scaler (PS) and untreated surfaces (UT). The bars represent average surface roughness (Ra) and the whiskers indicate standard error of the mean. ANOVA showed significant differences between the groups ( $p < 0.0001$ ). Follow-up analysis with the Tukey-Kramer HSD test showed no difference in surface roughness between MP and UT, surface roughness of PP and PS were comparable and higher than MP and UT ( $p = 0.05$ ), and surface roughness of MS was higher than all other groups ( $p = 0.05$ ).

Section scores were used for comparison analysis. ANOVA showed significant differences in surface roughness between the untreated and treated surfaces ( $p < 0.0001$ ) (Figure 6). Add hoc analysis using Tukey-Kramer HSD test showed no statistical differences between untreated measures and metal probe measures. On the other hand, statistical differences were noted between untreated measures with plastic probe measures ( $p = 0.05$ ), plastic scaler measures ( $p = 0.05$ ) and metal scaler measures ( $p = 0.05$ ). The metal scaler measurements were higher than plastic probe measures ( $p = 0.05$ ), and plastic scaler measures ( $p = 0.05$ ).
